# Field Survey of Permeable Pavement Surface Infiltration Rates

Eban Z. Bean<sup>1</sup>; William F. Hunt<sup>2</sup>; and David A. Bidelspach<sup>3</sup>

**DOI:** 10.1061/(ASCE)0733-9437(2007)133:3(249)

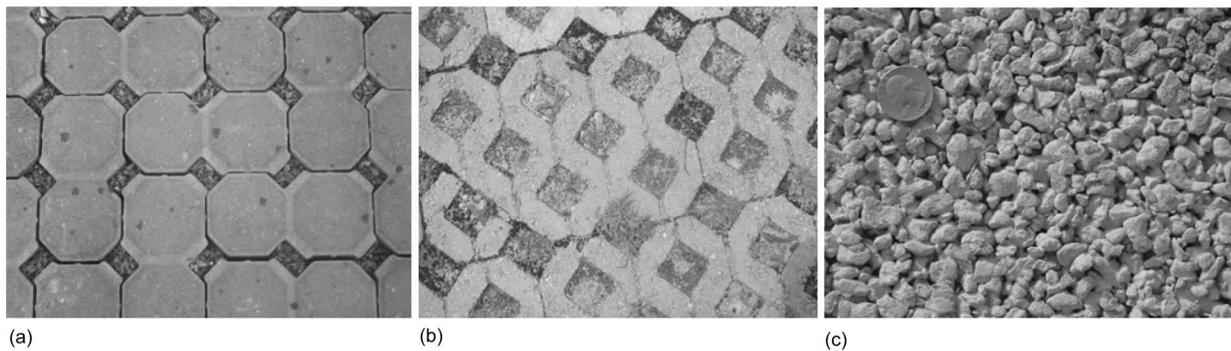
Fig. 1. (a) PICP; (b) CGP; and (c) PC

Figs. 1(a–c) show examples of concrete grid pavers (CGP), permeable interlocking concrete pavers (PICP), and porous concrete (PC). A procedure, photoanalysis, used close-up photographs of surfaces to determine the percent of a permeable pavement surface area that was impermeable due to the pavement block itself. The remaining surface area was considered to be the open or void area. CGP paving systems are comprised of concrete blocks with internal voids and gaps between the blocks. Photoanalysis determined that CGP surface was approximately 30%

open, or void. In this study, the sites examined had voids either filled with sand or No. 78 stone; a gradation is listed in ASTM D 448-03a (ASTM 2003b). PICP are concrete block pavers that, when placed, have voids located at the corners and midpoints of the pavers. Photoanalysis determined that PICP surface was at least 9% open, or void. Most recent research that has been conducted on permeable pavements has examined PICP (Balades et al. 1995; Pratt et al. 1995; Gerrits and James 2002). PC is different from standard concrete, in that fine aggregate has been removed from the mix, allowing interconnected void spaces to form during curing.

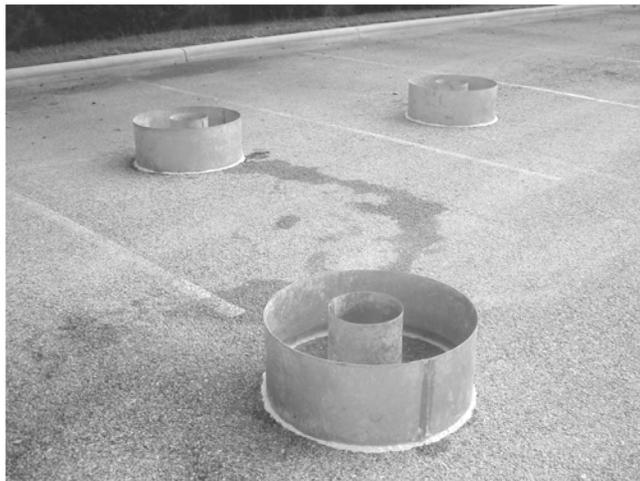
**Fig. 2.** Double-ring infiltrometer test

Once locations were selected for testing at each site, the inner ring was sealed to the test surface. A thin ribbon of plumber’s putty, about 40 mm (1.5 in.) wide, was molded along the bottom edge of the inner ring. The ring was then placed on the putty and pressed to the surface. The putty was depressed to form a tight seal between the surface and the ring. The inner ring was then filled with water to a depth of approximately 50 mm (2 in.) above the testing surface to determine if there was any leakage to the outer ring, and whether the hydraulic head would be maintainable during a double-ring infiltrometer test (DRIT). A hydraulic head was determined to be maintained if the water level rose while dispersing water into the rings using a submersible pump with a maximum flow of 25 gpm. If the hydraulic head was maintained during the trial, then a DRIT was conducted on the surface. The outer infiltrometer ring was sealed to the surface using plumber’s putty in the same manner as the inner ring. The outer ring was then filled to a depth of approximately 50 mm (2 in.) above the testing surface to determine if there was any leakage from the outer ring that could not be maintained. Fig. 2 shows three simultaneous DRITs being conducted.

Once all leaks, if any, were plugged or, for outer ring leaks, slowed enough to maintain a head equal to the inner ring, both the inner and outer rings were filled to a depth between 125 mm (5 in.) and 175 mm (7 in.). The initial level of the water in the inner ring, outer ring, and current time (effectively time 0) were recorded. All three parameters were measured and then recorded approximately every five minutes. Each water level measurement (inner and outer) was taken from the top of the inner ring to the water level from the same location along the rim. A test was complete when enough time, typically between 30 and 45 minutes, had elapsed to determine the surface infiltration rate. Tests were preceded by at least a 24 h dry period at all sites.

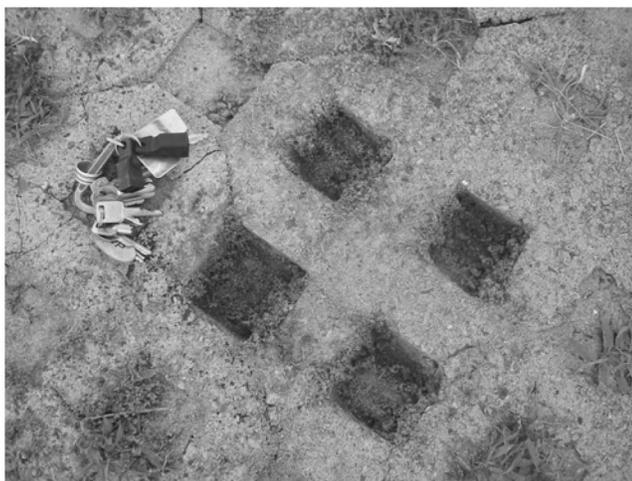
**Fig. 3.** Simulated maintenance on CGP surface

infiltration rates for CGP. At each CGP site, three tests were conducted under existing conditions. After the simulated maintenance, three more tests were conducted in different locations. An “existing” test was defined to be a surface infiltration test where the paver surface remained unaltered prior to the surface infiltration test. A “simulated maintenance” test was a surface infiltration test conducted when void material was removed to a depth between 13 mm (0.5 in.) and 19 mm (0.8 in.) to simulate maintenance by a street sweeper (Stevens Personal Communication, 2001). Fig. 3 displays a maintained CGP location. If the measured existing surface infiltration rates of a site were lower than 25 cm/h (10 in./h), a simulated maintenance test was run.

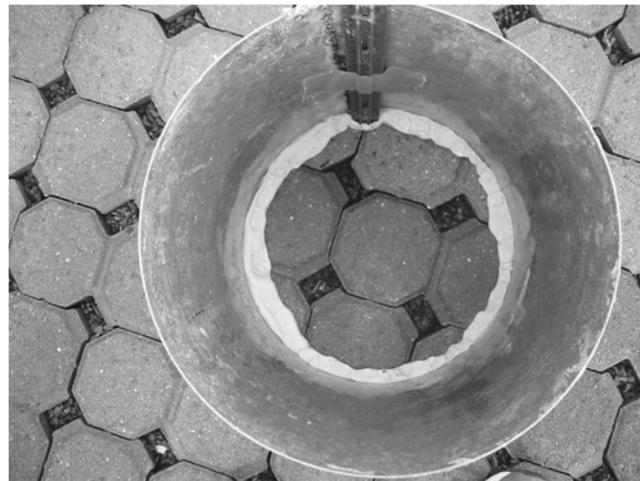
**Fig. 4.** SRIT test

Many sites had surface infiltration rates greater than the filling rate for the DRIT [ $>150$  cm/h (60 in./h)]. A modified version of the DRIT, single-ring infiltrometer test (SRIT), was performed at the sites. When conducting the SRIT, an inner ring of the double-ring infiltrometer was sealed to the test surface, and a scale was vertically taped inside the ring (Fig. 4). Using a 19 L (5 gal) bucket, water was quickly poured into the inner ring; recording time from the moment water started pouring in. The time was also recorded when all the water was emptied into the single ring (along with the peak level of water inside the ring), and again

every 30–60 s until the water completely infiltrated the pavement. If complete infiltration occurred in less than 30 s, the time to empty the ring was recorded. The test was then repeated at the same location and the two rates were averaged. The mean for that location was then averaged with the surface infiltration rates of the other two locations tested at the paver site to determine an overall surface infiltration rate. The SRIT is neither as accurate nor as precise as the DRIT, because the SRIT does not prevent horizontal migration of the water once it enters the media as well as the DRIT (Bouwer et al. 1999). However, it provided a method for quantifying the surface infiltration rate on highly permeable applications.

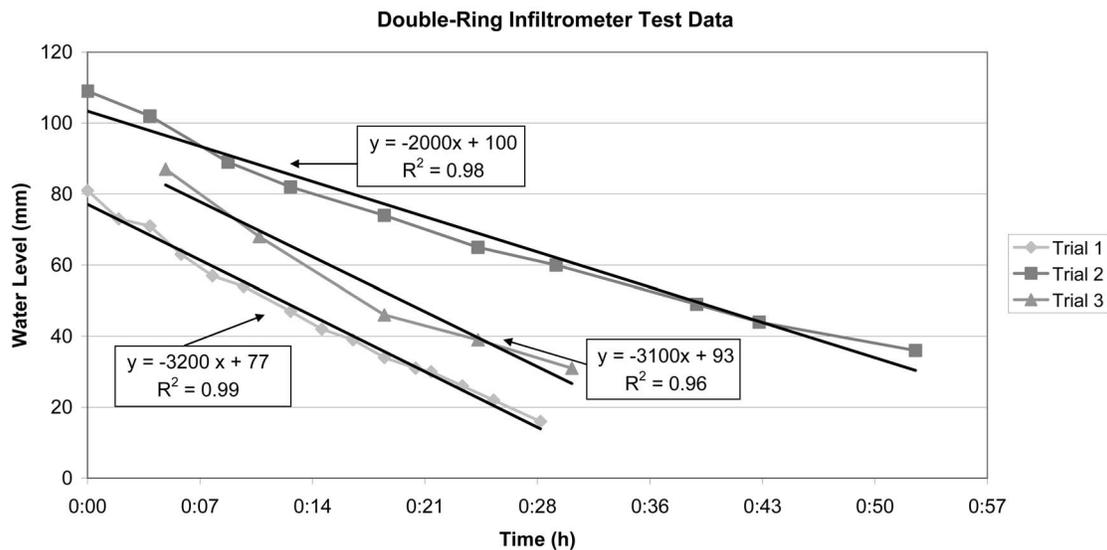
Fig. 5. Graph of DRIT data and regression lines from a CGP test in coastal North Carolina

After data were collected, the water levels were plotted as functions of time for each surface infiltration test (Fig. 5). The infiltration rate is equivalent to the maximum-steady state or average incremental infiltration velocity (ASTM 2003a,b). Therefore, the slope of the least squares line for each test was the surface infiltration rate of the permeable surface. Furthermore, if it was determined that removing the initial two or three data points from a test’s dataset caused the least squares line to be more representative of the surface infiltration rate, then those ini-

tial data points were omitted from the calculation of the least squares line. The stated surface infiltration rate for each site was determined by averaging the results from the three test locations. Finally, ASTM D 3385 states that the hydraulic conductivity and infiltration rate “cannot be directly related unless the hydraulic boundary conditions are known or can be reliably estimated” (ASTM 2003a,b). Therefore, since these characteristics are unknown, the hydraulic conductivities cannot be determined from the data collected in this study.
